Cushcraft R5 $\frac{1}{2}$ λ Vertical Maintenance and Repair

CUSHCRAFT R5 (10/12/15/17/20 m)

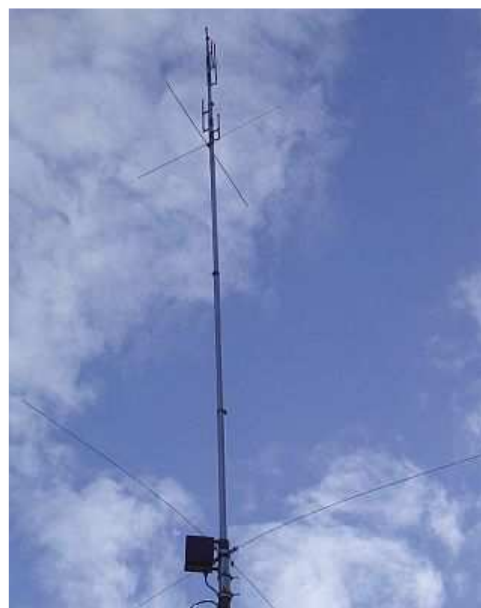
R5 a 5 band vertical on top of a 12 m mast.

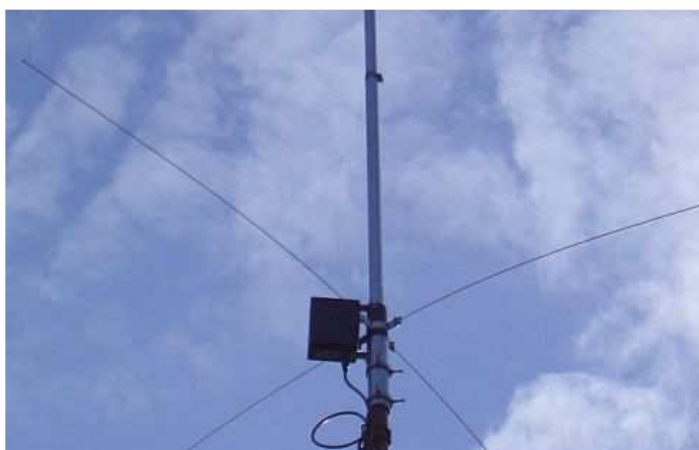
This antenna is very usable and, being asymmetrically fed, with no radials and only 4×1.24 m stainless steel whips («fig) is attractive for apartment dwellers. All hardware is aluminium or stainless steel. The aluminium durability is good but not as good as Fritzell's tubing. It has withstood many heavy windstorms without a problem and currently is bent over at about a 10 – 15 degree angle. It is rugged and not too tall mounting without guy ropes. This antenna is sensitive to metal objects in near field. Prevent installation over a metal roof or near out other antennas because they will detune the R5 considerably.

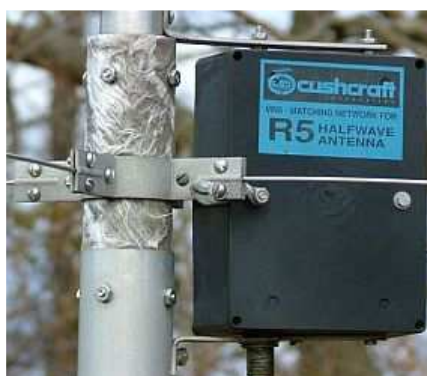
The fibreglass base insulator (fig a) is a polyester-coated tube. The polyester surface has the tendency to "evaporate" and the bare glass fibres then are like a sponge attracting absorbing dirt and moisture.

Fig a: A bare weather beaten insulator.

The insulator was "painted" with layers of 2 component polyester resin and sprayed (fig») with "bumper spray", a black non-metallic spray paint. It prevents the deterioration of the polyester.

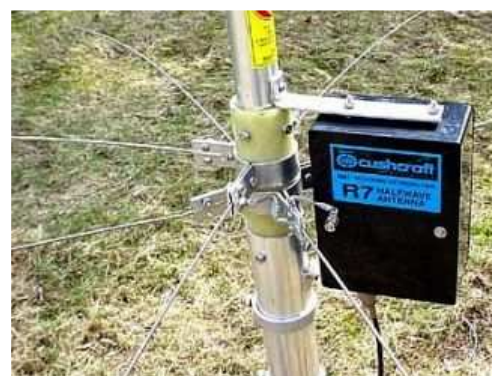
Fig b: An unprotected new R7 insulator.

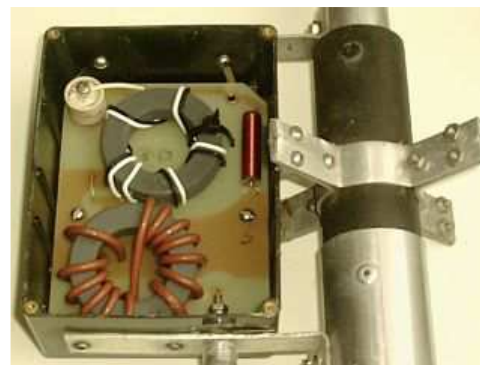
Insulator protected with black non-metallic spray paint.

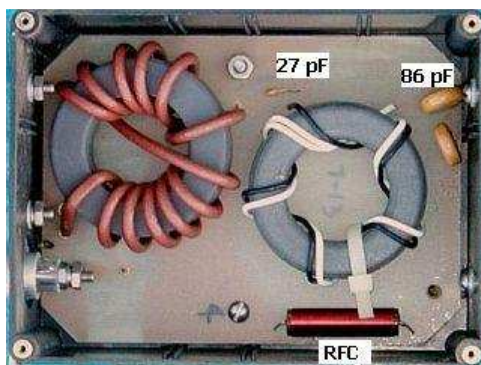
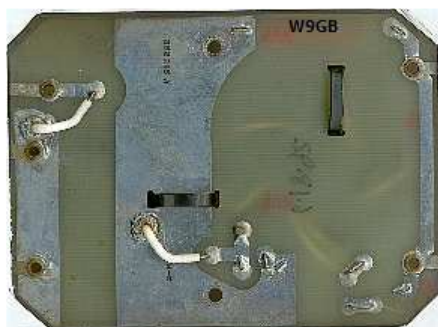
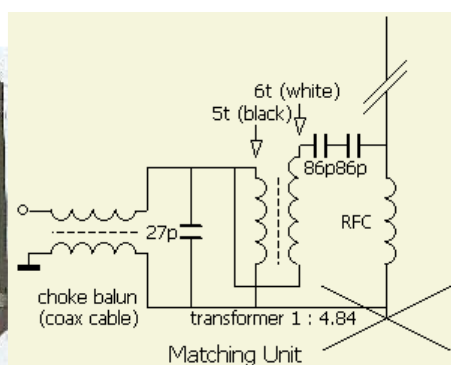
L to R: choke balun (brown colour wire) and 1 : 4.84 auto transformer (black and white colour wire).

On several homepages the transformer is called a 1 : 4 balun. That is contrary to the print design. On the auto transformer are 5 black turns and 6 white turns through the toroid. So the transformer step up ratio is 5 : (5 + 6) and that is an $5^2 : 11^2 = 1 : 4.84$ impedance ratio. All matching units' shows equally designed print boards.

I replaced the two 86 pF caps in series with a single transmitting high current 47 pF doorknob type.

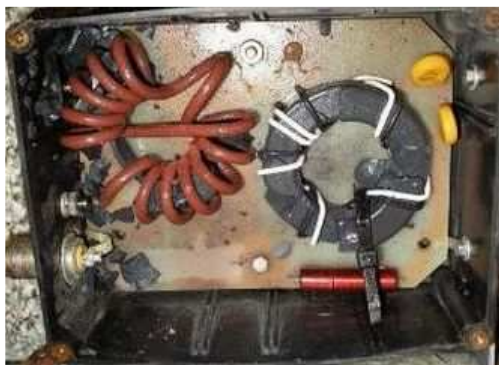
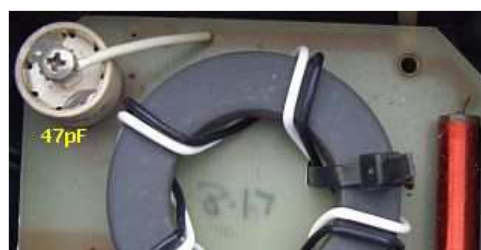
This happens if one use the antenna with an ATU and a lot of power on more than the specified 5 bands!

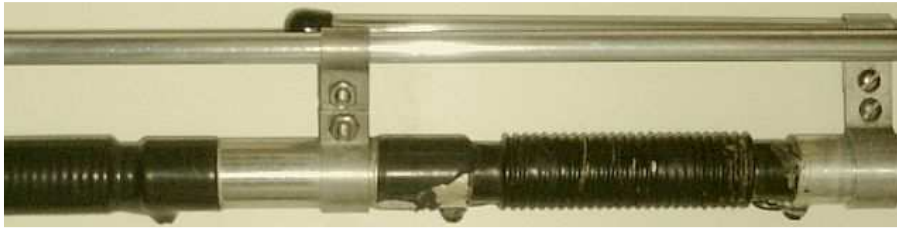
Water got inside a trap due to cracked heath shrink tubing.

Leaking spots are the heath shrinks tubing over the bolt onto the connection of the coil former with the tube.

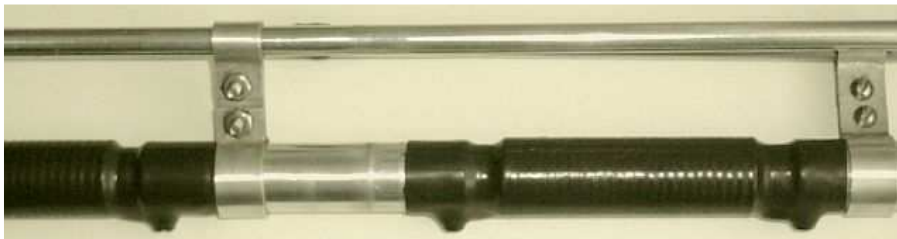
Cleaned and repaired coil

adhesive is for preventing that water gets inside the trap.

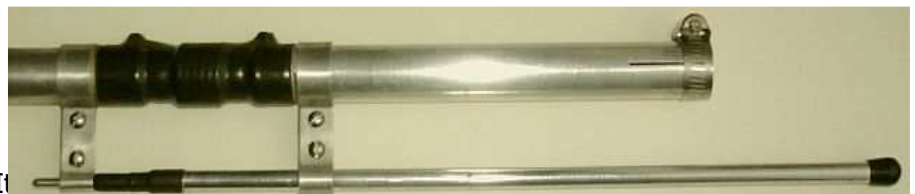
One capacitor failed because of a burst cap and water get into the coaxial system. This changed the dielectric constant of the capacitor, thus moving the resonant frequency, and the SWR increased dramatically. Flash-overs when running high power shorted the wet capacitor out and evaporated a part of the insulating tubing.

This was replaced with a short piece of PTFE tubing and all of the components were dried, cleaned and reassembled with contact cement and heath shrink tubing.

It seems that glue sticks («fig) for a glue gun are suitable for replacement of the

insulating tubes.

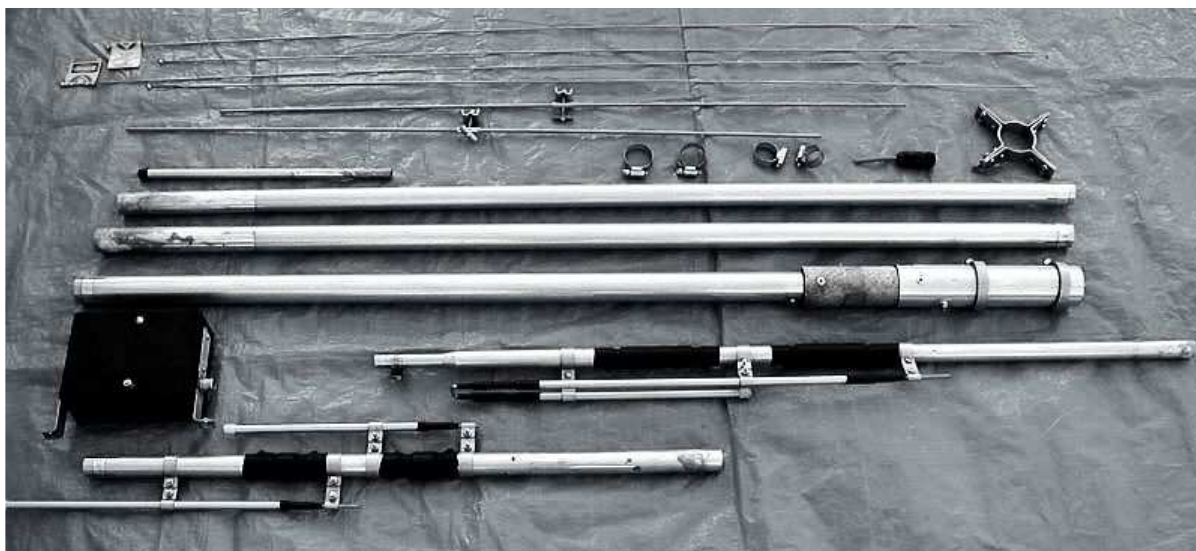
All R5 parts of the 1989 model.

Measuring the traps is only possible by comparison with another R5. Make sure that you do not touch any part of the antenna and vary the frequency of a (grid) dipper meter until a strong dip is seen. Move the meter away while retuning until a very shallow dip is seen. Take note of the trap frequency. Repeat this process with the repaired R5.

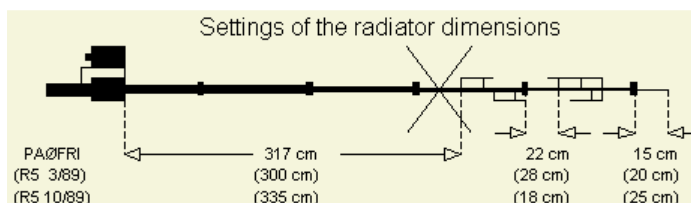
With the antenna on a 2 m mast I measured the SWR, on each band with a half wave (or multiple) 50 Ω cable for that band between the feeder point and an analyser. I found the dimensions in the schematic by varying the sections to match the specifications for SWR ~ 1

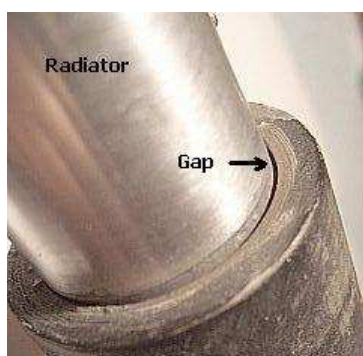
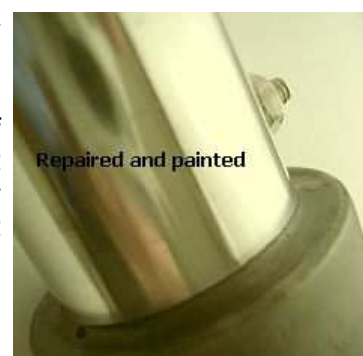
The antenna wobbled due to the gap caused by evaporation of the polyester. The tube was removed, the inside of the insulator applied with layers of 2 component polyester resin until a minimum variation of fit. Then I sanded the insulator for a perfect cylindrically curved shape and applied the last layer and placed the antenna back in the insulator. In fact the insulator was restructured to its original diameter.

I used a polyester repair set (for automobile) and

applied the 2 component polyester resin with a brush.

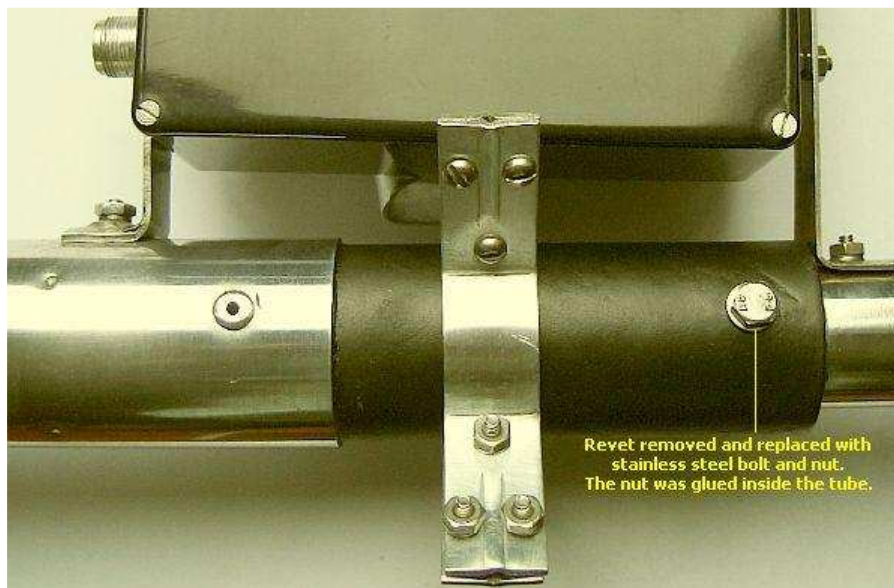
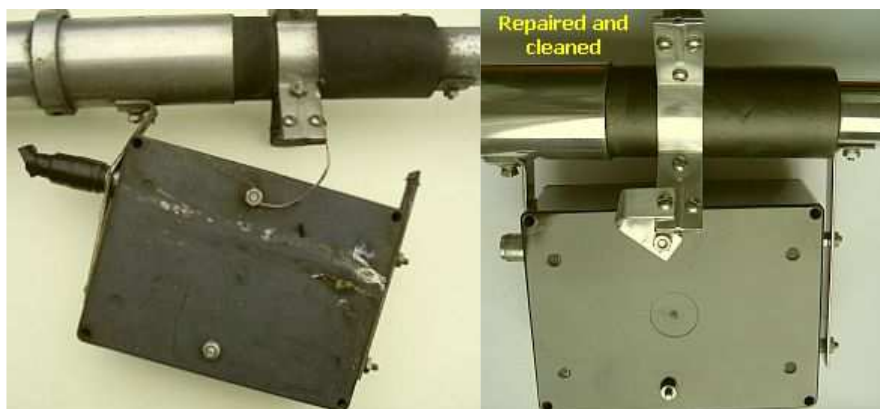
Due to the gap the antenna wobbled and one of the straps was broken.

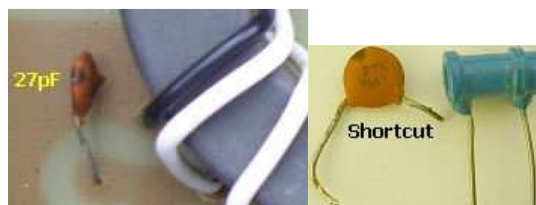
I replaced a shortcut 27 pF cap with 4 × ceramic tube caps in series/parallel.
